Juneau Airport Wind System (JAWS) Wind Sensor Severe Weather Performance Test Report

August 2002

DOT/FAA/CT-TN02/18

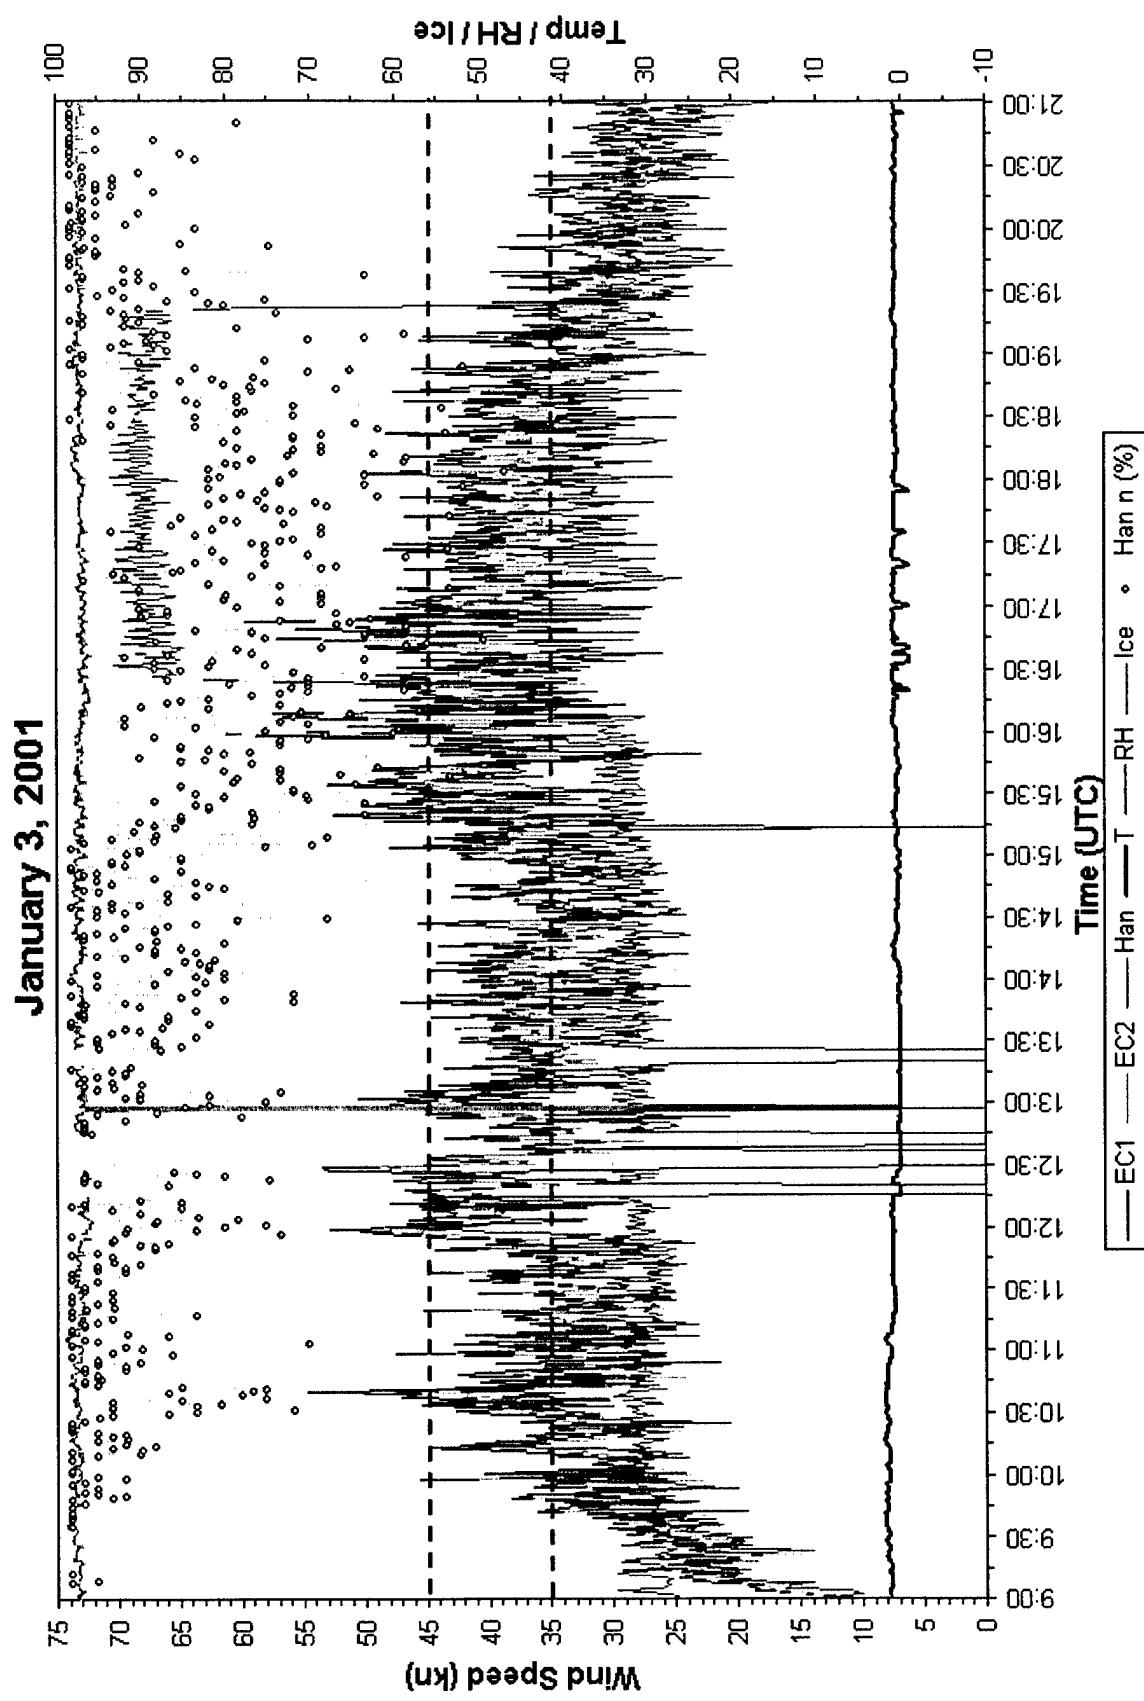
Closer inspection was performed to determine the validity of the affected 1-minute average values when ice was apparent on the anemometer. Time series of Vaisala wind speed and direction values during significant icing events are depicted in figures 71 through 77. In these figures, the sample size of valid data, in percent, comprising the 1-minute averages is shown in yellow against the secondary ordinate axis.

FIGURE 71. VAISSALA 1-MINUTE WIND SPEED AVERAGES DURING AN ICING EVENT

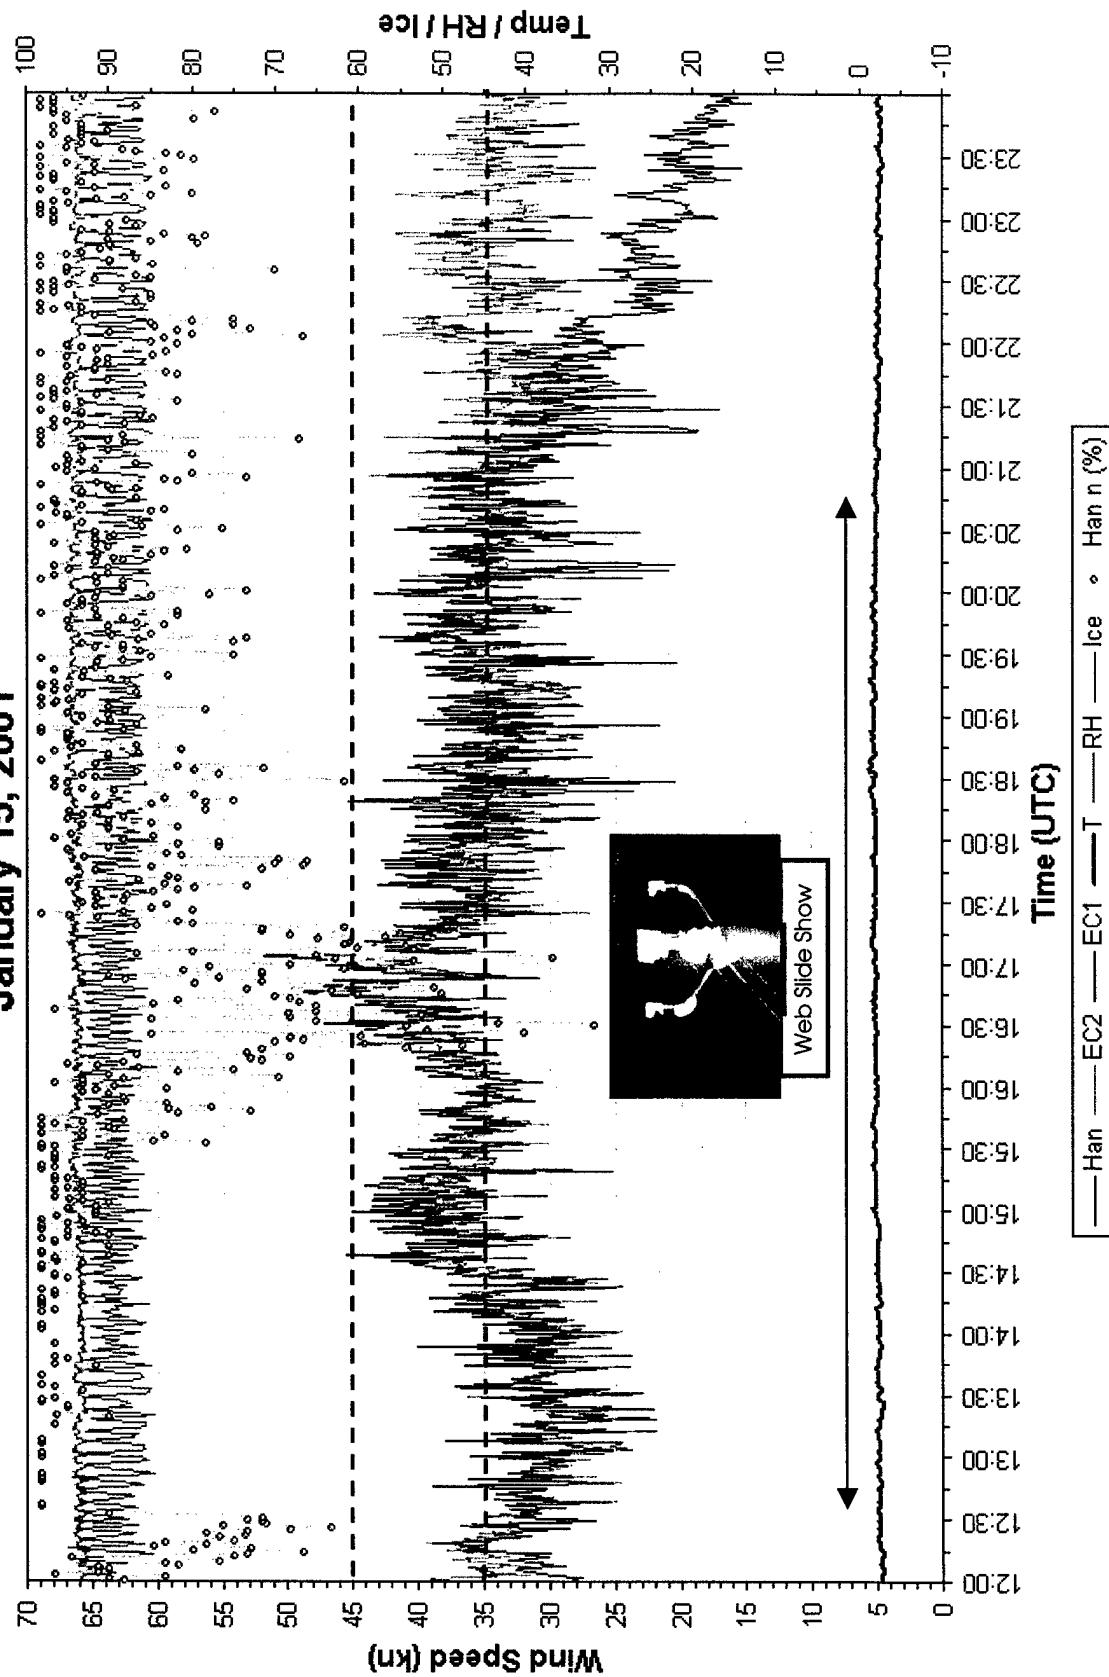
FIGURE 72. VAISSALA 1-MINUTE WIND SPEED AVERAGES DURING AN ICING EVENT

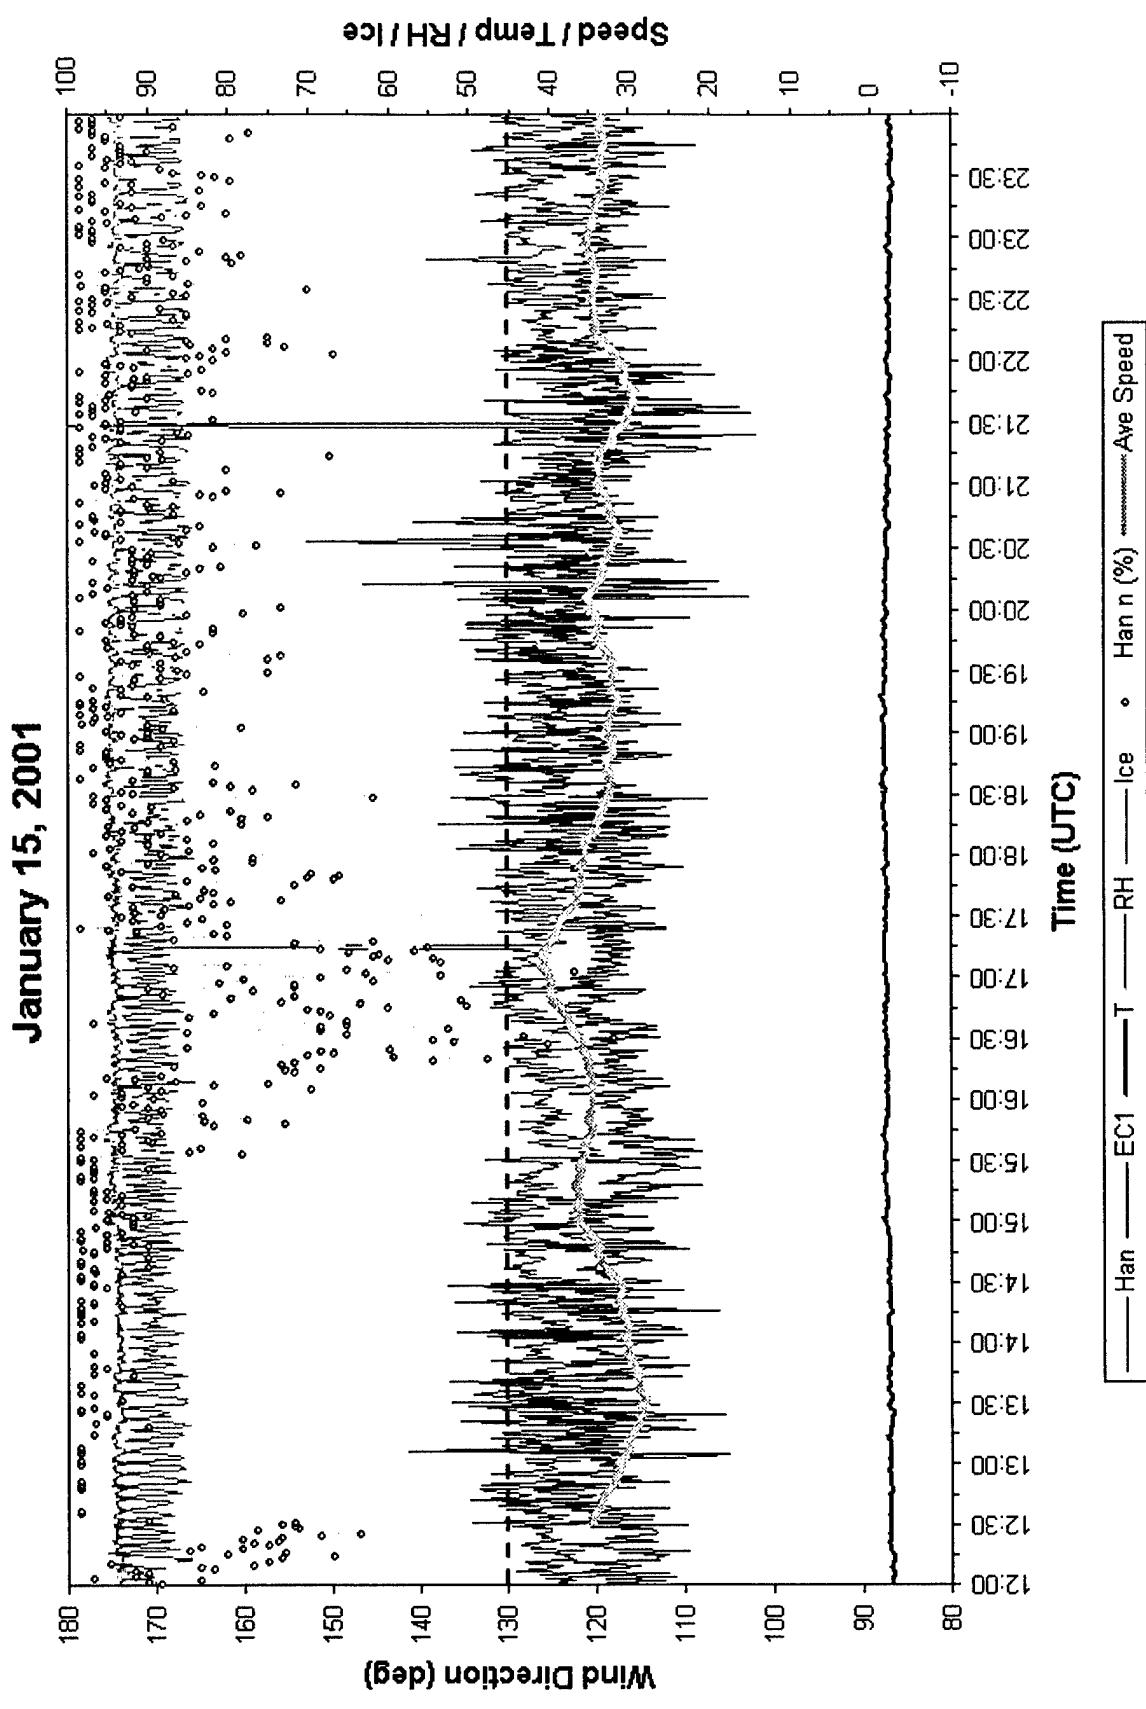
FIGURE 73. VAISALA 1-MINUTE WIND DIRECTIONS DURING AN ICING EVENT

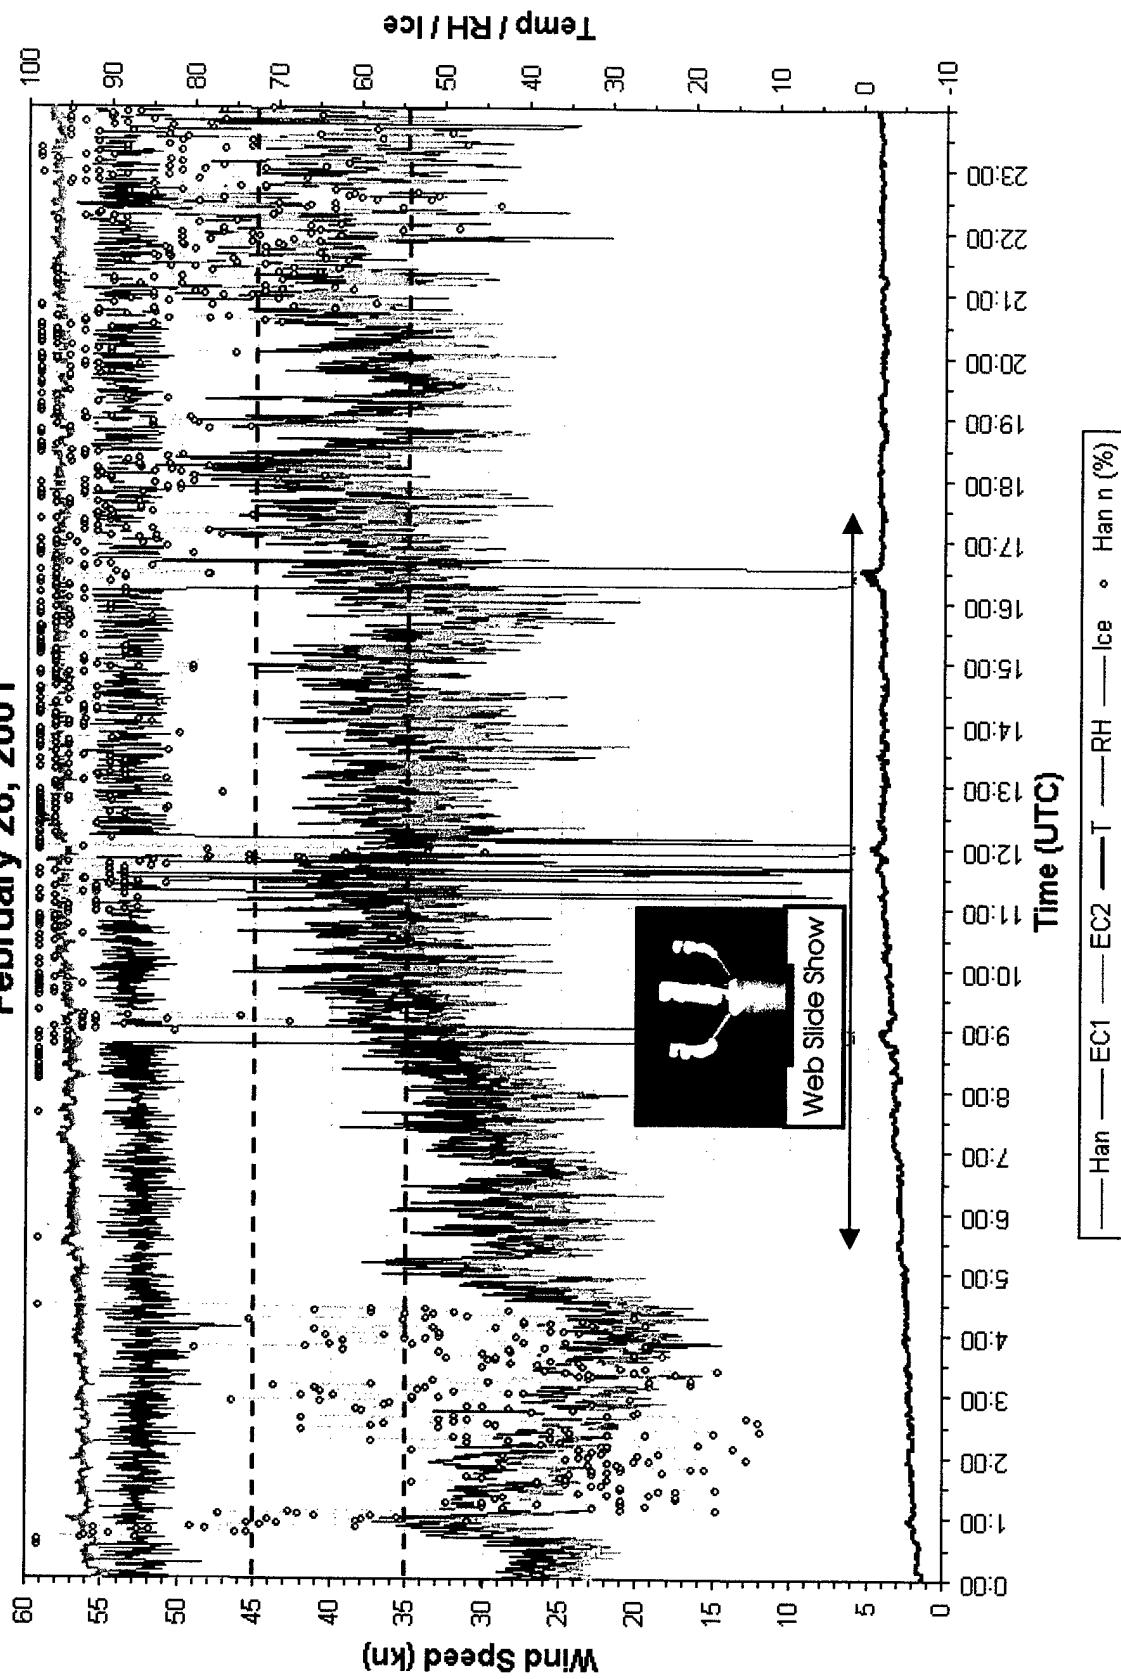
FIGURE 74. VAISALA 1-MINUTE WIND SPEED AVERAGES DURING AN ICING EVENT

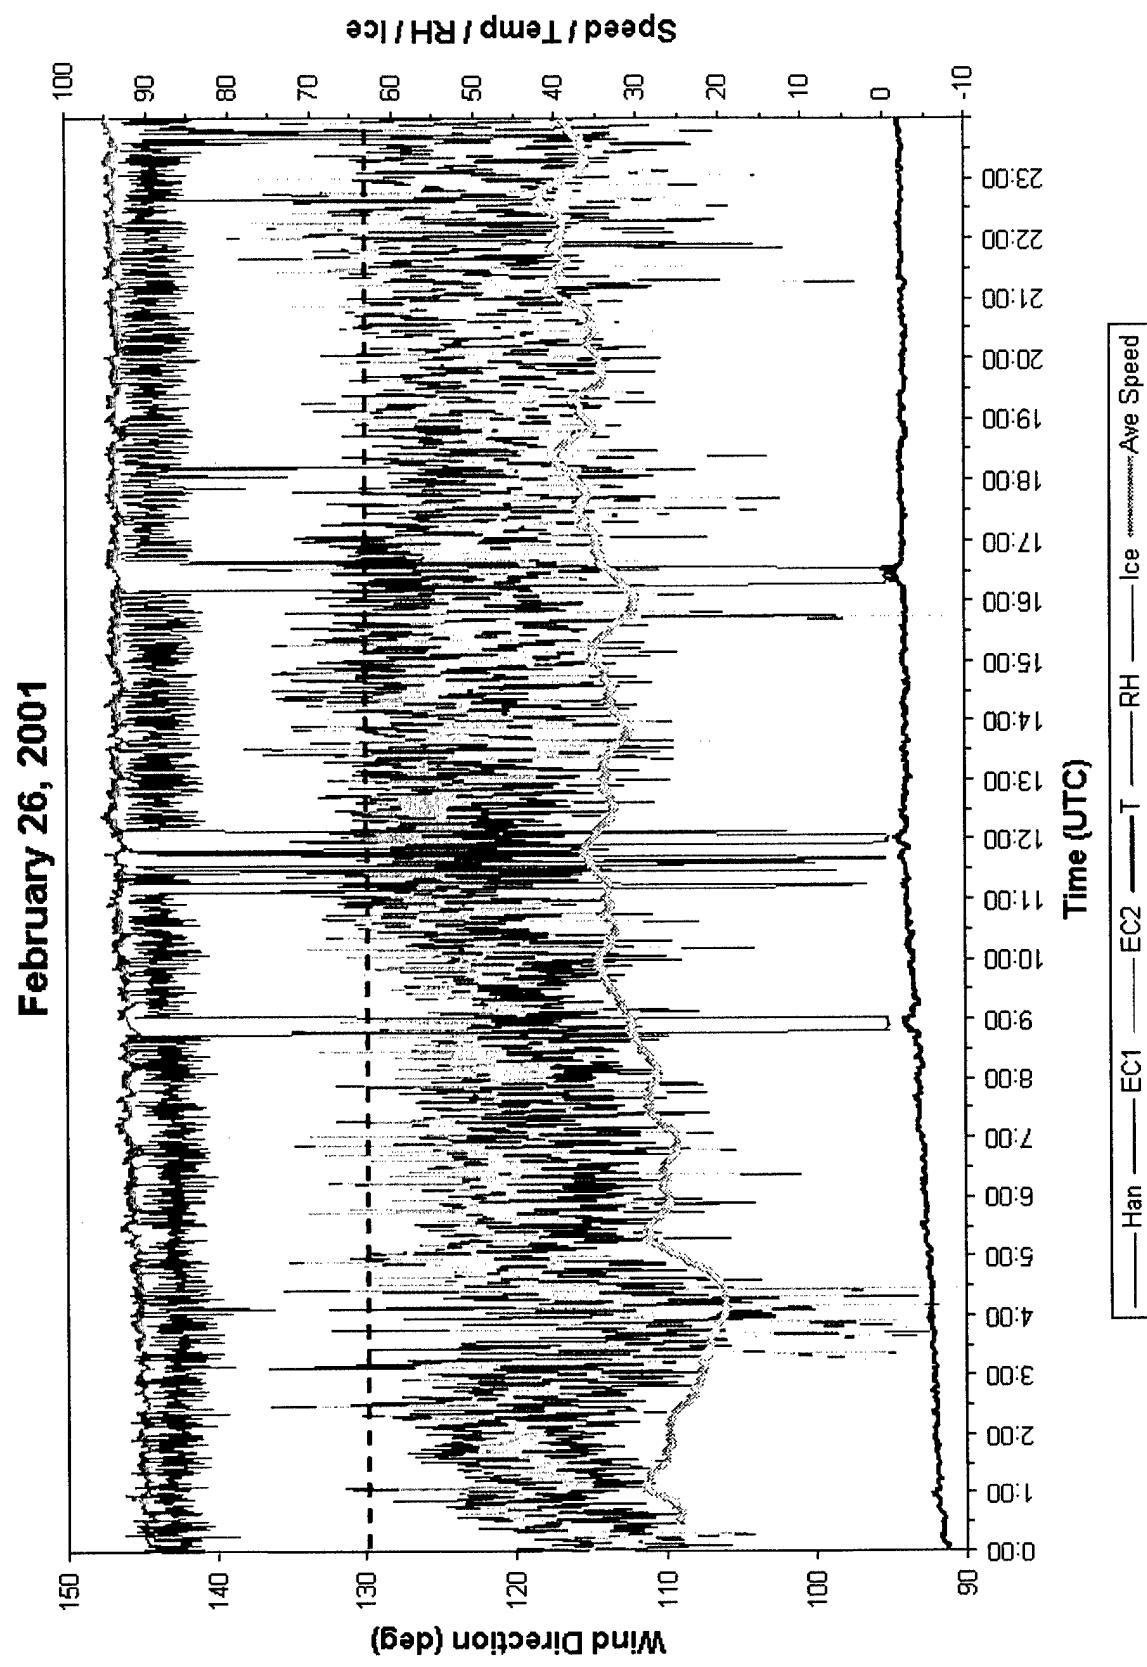
FIGURE 75. VAISALA 1-MINUTE WIND DIRECTION AVERAGES DURING AN ICING EVENT

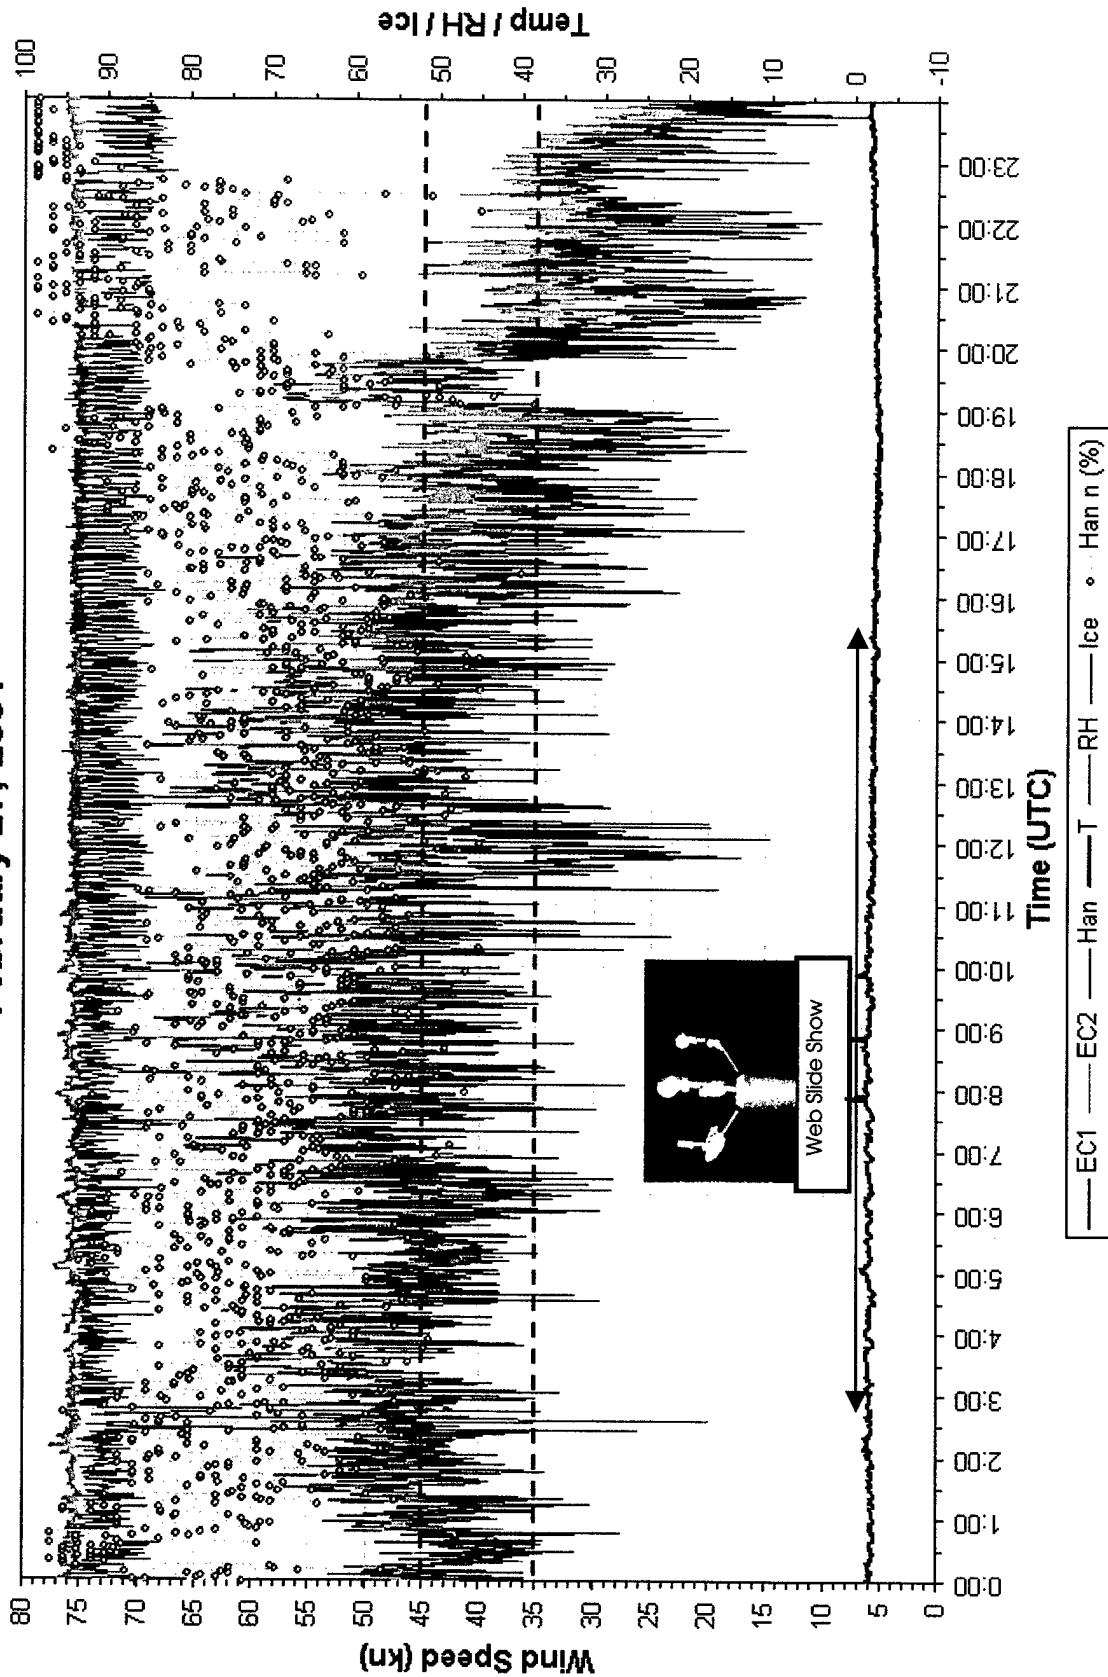
FIGURE 76. VAIISALA 1-MINUTE WIND SPEED AVERAGES DURING AN ICING EVENT

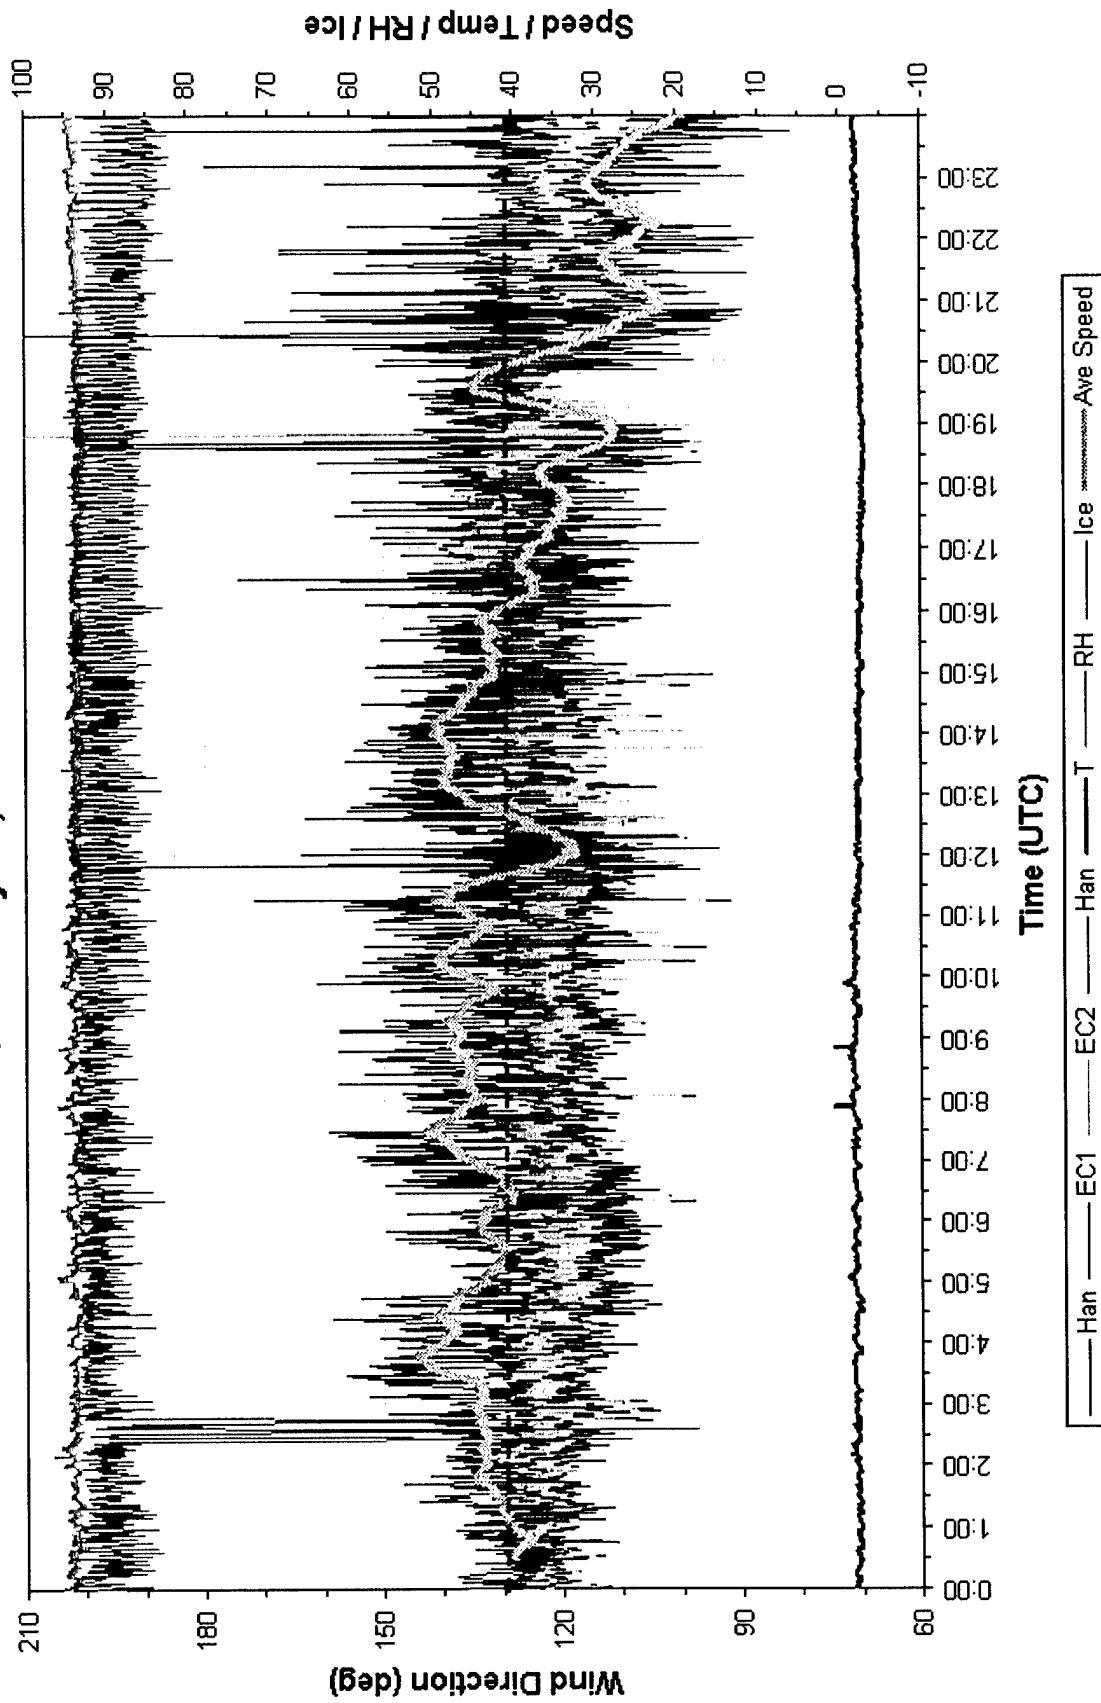
FIGURE 77. VAISALA 1-MINUTE WIND DIRECTION AVERAGES DURING AN ICING EVENT

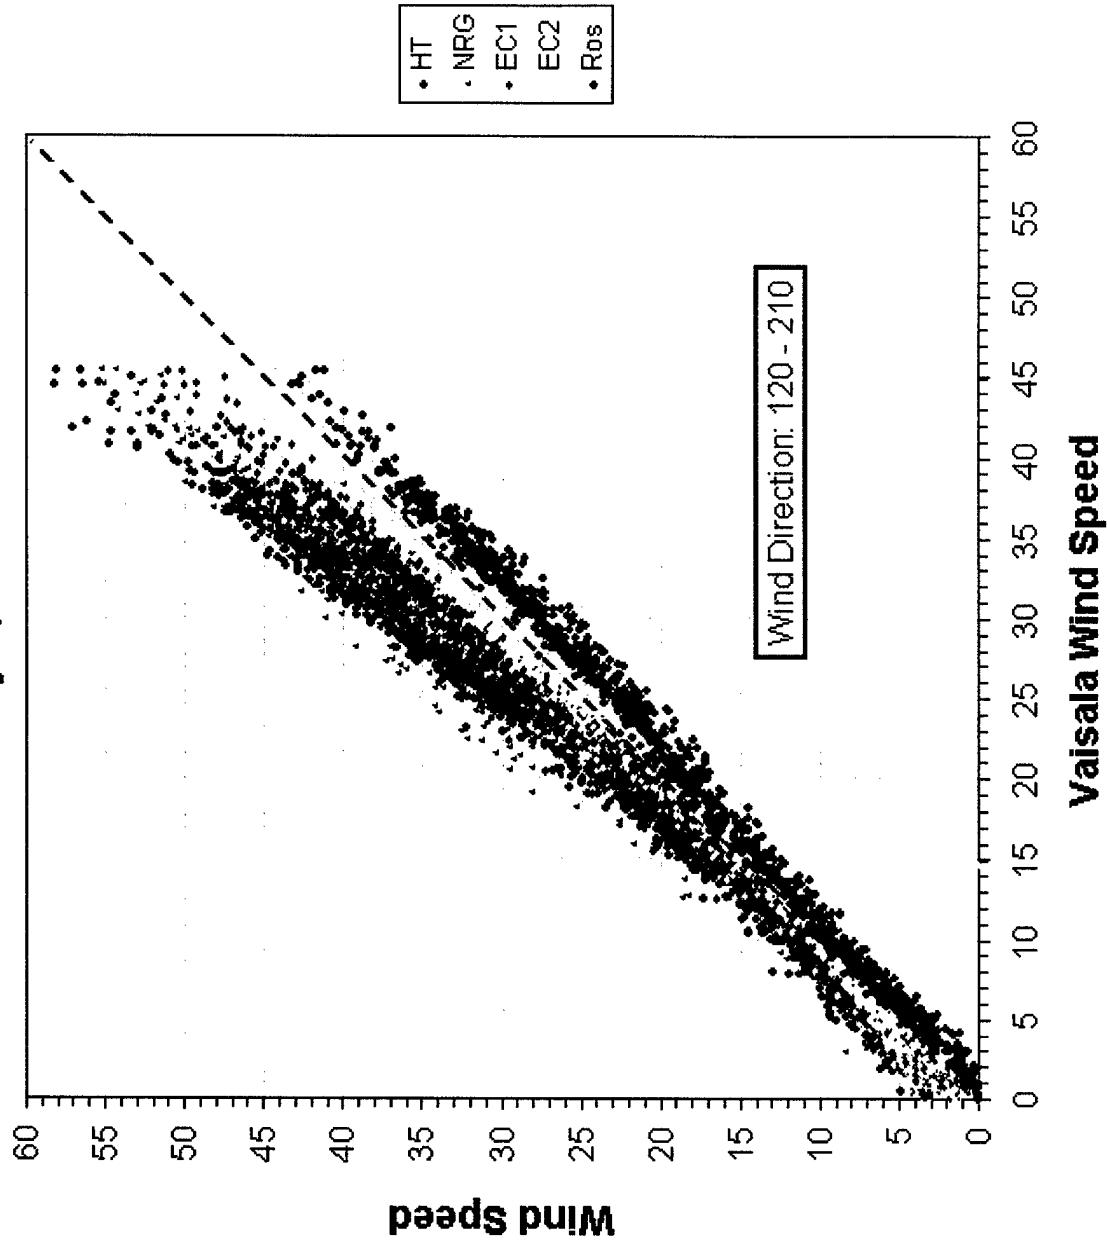
The Rosemount 1774W pressure-type probe exhibited optimistic performance as shown in figure 78. However, the sensor was installed late in the season and the resulting data set was unfortunately limited.

FIGURE 78. WIND SPEED DISTRIBUTION FOR SOUTH WIND

- b. Based on the success of the test bed setup, and encouraging results obtained from the sensor assessment, it is recommended that a follow-on study be implemented for the Juneau winter of 2001–02. The purpose of the effort is to further assess the 425AH capabilities with various heater modifications. In addition, it is recommended that the Metek sensor be implemented to determine the effects of upslope winds, and the Rosemount 1774W be further evaluated.
